# TEST REPORT

**Sample name:** 200mm High Power Traffic Light  
**Trade Name:** N/A  
**Specimen Model:** NBVB213HP, NBAL213HP-V12, NBPS212HP-V12, NBVB212HP-V12, NBPS200HP-V12, NBAL200HP-V12, NBVB200HP-R, NBVB200HP-A, NBVB200HP-G

**Types of Test:** Random vibration test

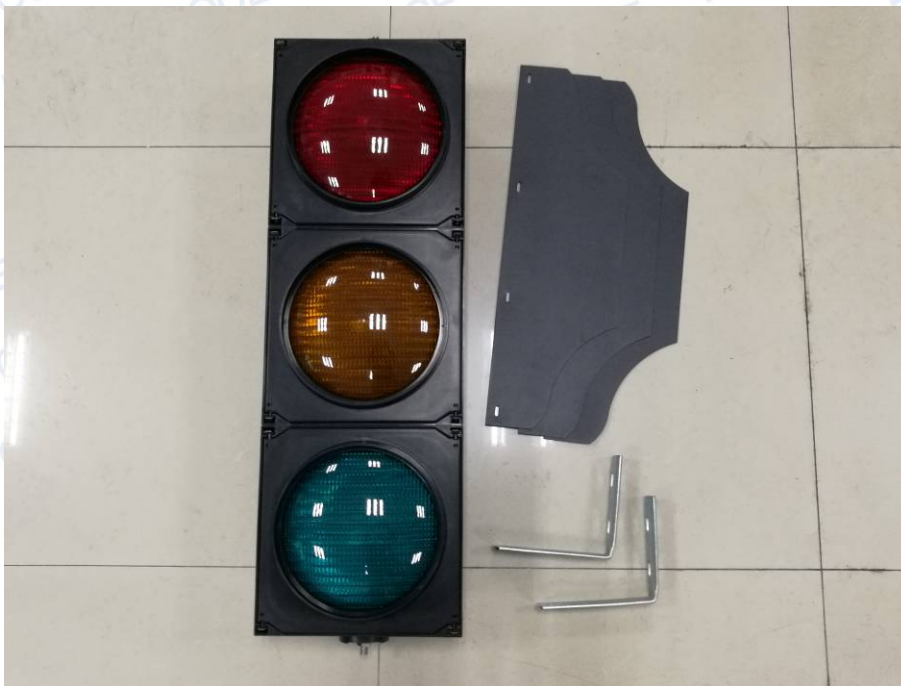
### Photo 1

☒ front

Each signal light, operating, has been fastened with screws. By means of the supplied L-shape brackets, to steel beam, integral to the vibrating test bench.

For the control of the vibration stresses two acclerometers have been used(One for NBVB213HP vertical axis vibration). Fixed to the to the shaker's integral support.

Hereafter photos of the layout for the tests along the three axes for each tested signal and a ASD(G<sup>2</sup>/Hz)/frequency(Hz) plot recorded during the tests:
