## TEST REPORT

**Sample name:** 300mm High Power Traffic Light  
**Trade Name:** N/A  
**Specimen Model:** NBVB313HP-V12, NBAL313HP-V12, NBPS312HP-V12, NBVB312HP-V12, NBPS300HP-V12, NBAL300HP-V12, NBVB300HP-R, NBVB300HP-A, NBVB300HP-G  
**Manufacturer:** SHENZHEN NOBLE OPTO CO., LTD.  
**Address:** Building 5F, Mingjinhai Industry Park, Shiyan Town, Bao'an District, Shenzhen, China, 518108  
**Date EUT received:** Jan. 03, 2018  
**Date test effected:** Jan. 03, 2018- Jan. 08, 2018  
**Types of Test:** Random vibration test

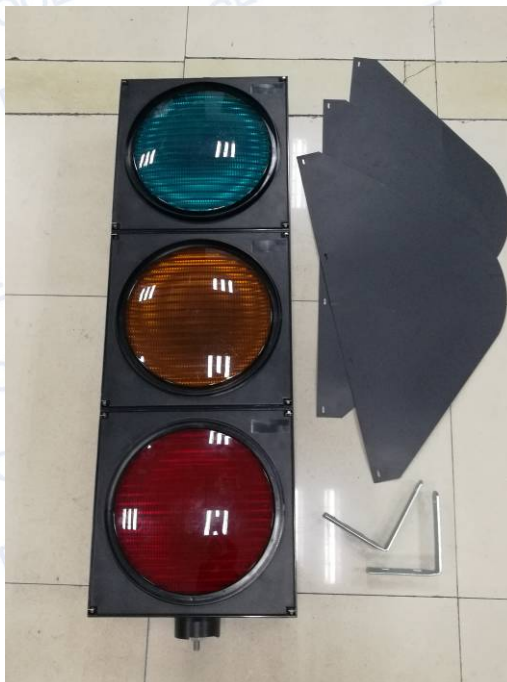
### Photo 2

Each signal light, operating, has been fastened with screws. By means of the supplied L-shape brackets, to steel beam, integral to the vibrating test bench.

Hereafter photos of the layout for the tests along the three axes for each tested signal and a ASD(G<sup>2</sup>/Hz)/frequency(Hz) plot recorded during the tests:
