Accompanying materials
to the tour

Royal chapel and Prismatic Tower

Muzeum města Brna

hrad Špilberk

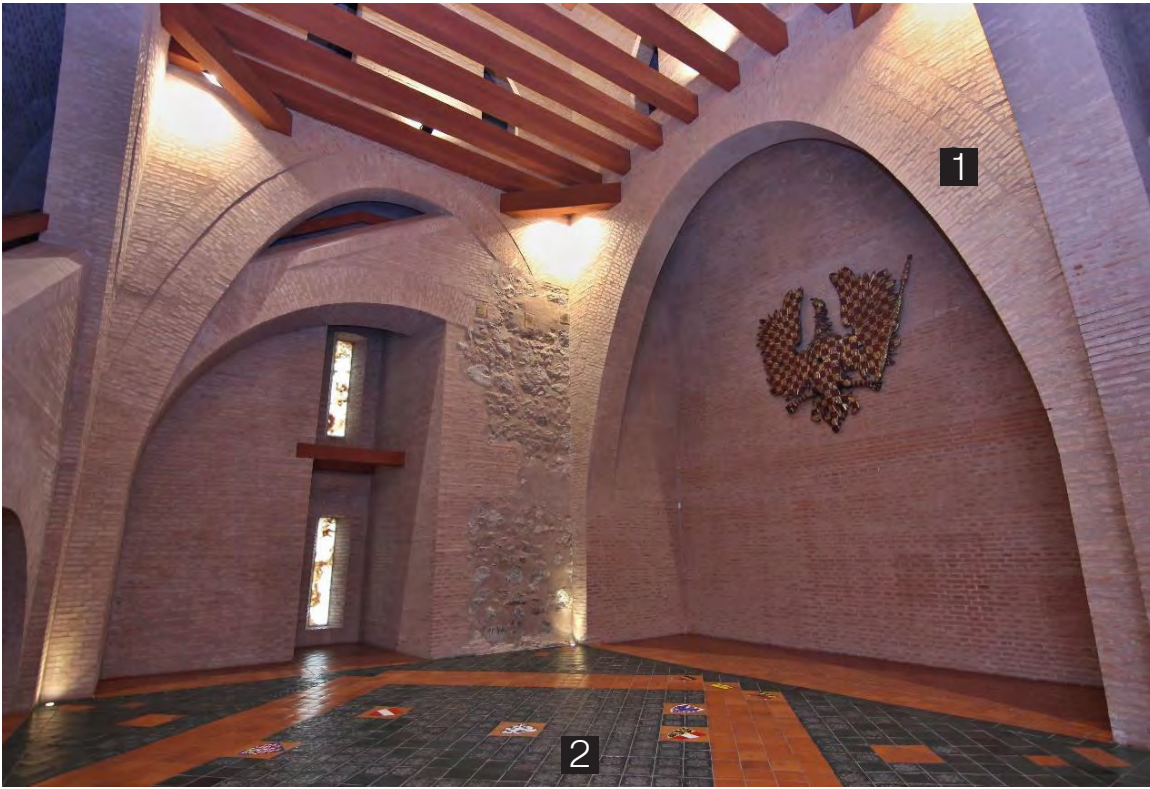
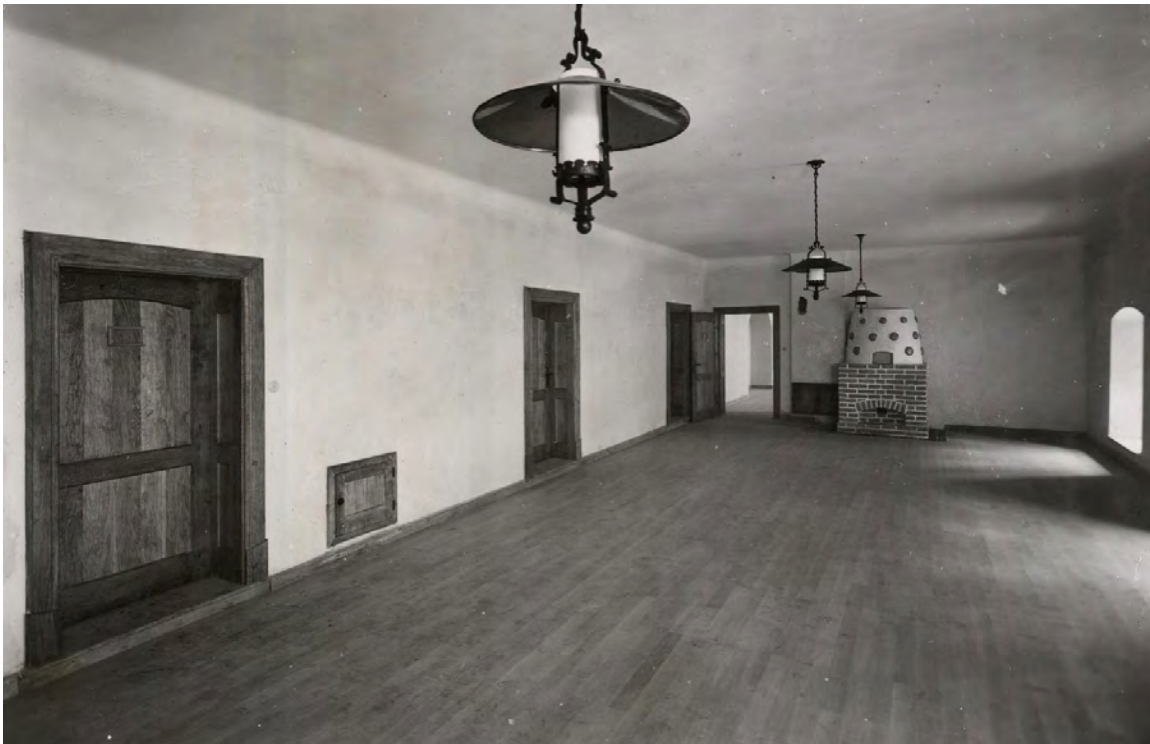
Square tower

The square tower after the reconstruction for the purposes of the Wehrmacht between 1939 and 1941.

The square tower was an important part of the defence system of the original medieval Špilberk Castle. The rectangular structure with dimensions of 13×14 metres protected the eastern entrance gate to the castle and at the same time, thanks to its strong walls, it could serve as the last line of defence for the castle's defenders. Originally, several floors were built into the tower, and the virtually windowless space could look very gloomy. However, the safety of the inhabitants of Špilberk required such a solution.

During the baroque reconstruction of the fortress, a practical use was sought for the dark rooms with extremely thick walls. In the end, the decision was made to turn them into prison cells for soldiers of the Špilberk barracks serving sentences. These rooms then served the same purpose in 1939-1940, when the Wehrmacht and the Gestapo took control of Špilberk. The cells in the former square tower served as solitary confinement cells for detainees who needed to be isolated from other prisoners.

During the reconstruction of the eastern wing of the castle in 1999-2000, it was decided to partially rehabilitate the original function of the defensive tower. The baroque floors of each storey were removed in an attempt to highlight the monumental open space of the building. To strengthen the incomplete medieval perimeter walling, an interesting modern element was used, namely the completion of brick strips in the shape of a parabolic arch

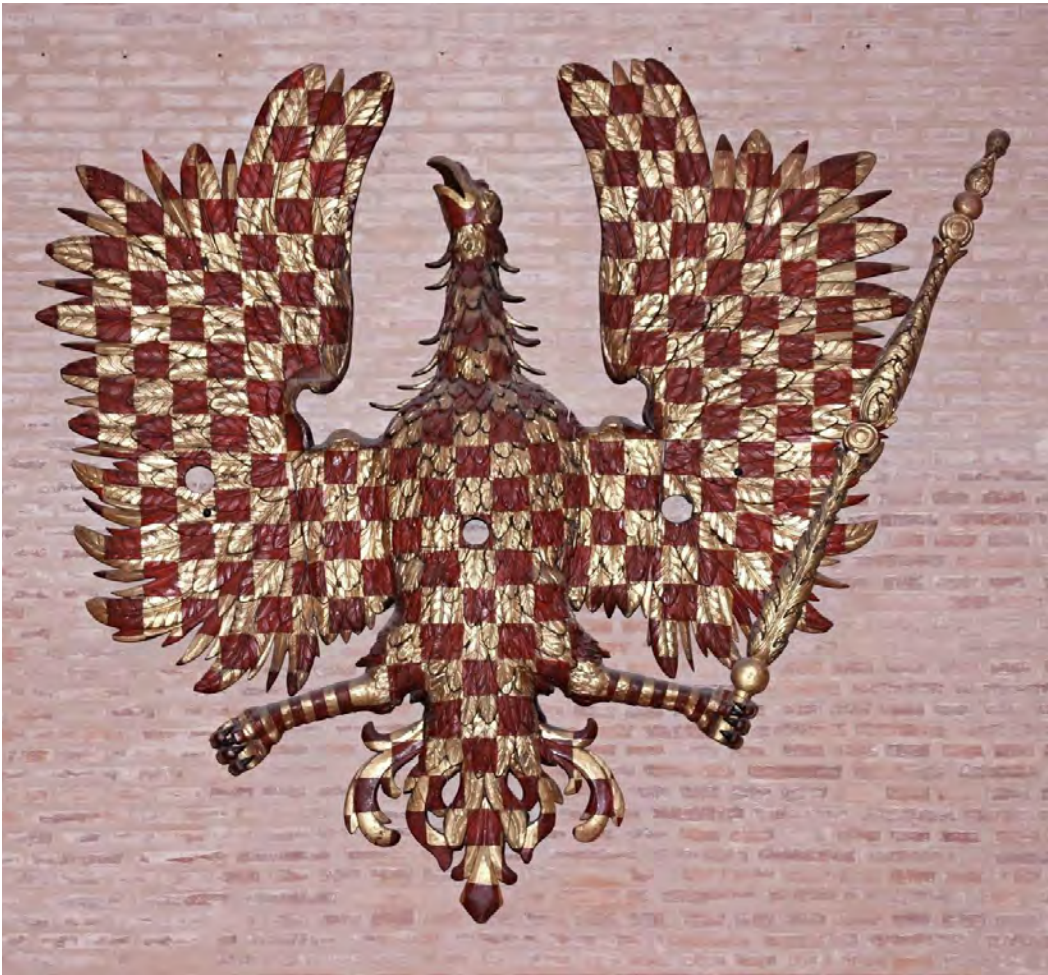
Moravian Eagle

One of the museum's interesting collection items is displayed on the wall in the square tower. It is a Moravian eagle from the first half of the 18th century. It is carved from lime wood and has an interesting design, where the necessary volume for the eagle's body was obtained by assembling wooden parts. The wings are attached at the root of shoulders by a system of wedges and screws.

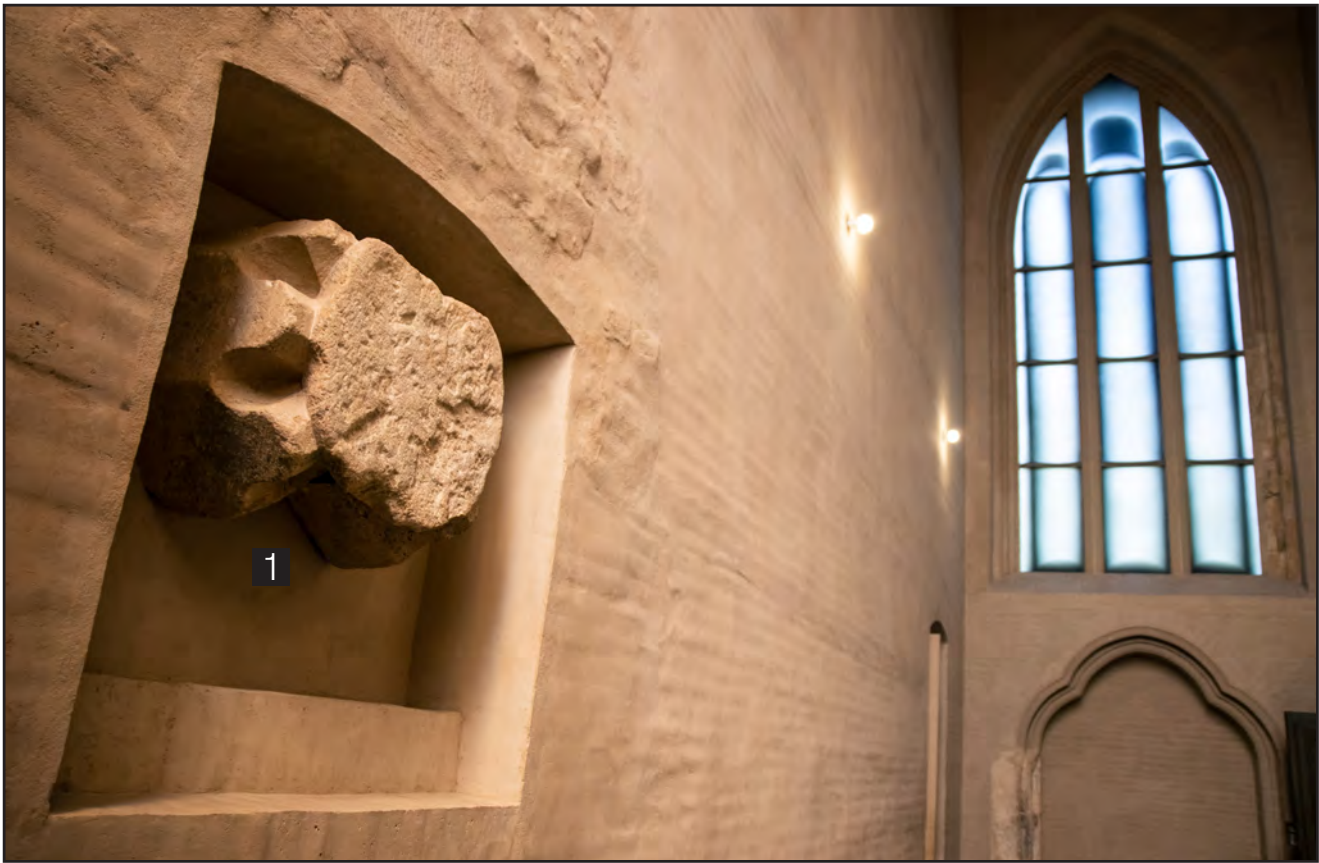
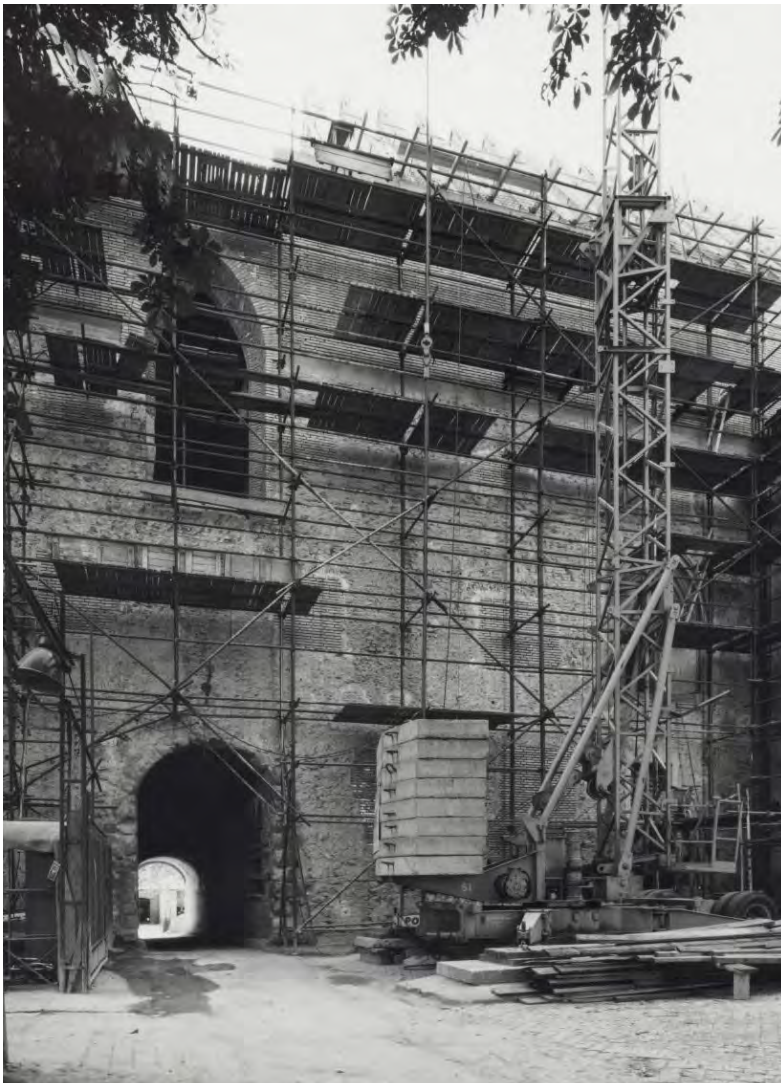
Space above the passageway

During the reconstruction, a keystone **1**, which is bricked up here, was found in the backfill of the vault. Originally, the ceiling space might have been topped with a cross vault, similar to the one in the Gothic hall we visited.

View of the eastern wing of the castle from the small courtyard during the reconstruction. Photos from the second half of the 1990s.

The original function of the superstructure above the eastern gate to the castle could not be ascertained either from written sources or during building-historical research. It is very likely that the space was divided into several floors. However, one hypothesis considers the use of the hall as it is open now, without horizontal divisions. This theory claims that in one of the construction phases of the medieval castle, a castle chapel was situated here. This would be consistent with the longitudinal orientation of the room, where the position of a possible altar faces the east, which is one of the conditions for the construction of a Christian sanctuary. However, in the environment of medieval castles often standing on exposed positions, their builders often did not have the possibility to orient the chapel correctly. Therefore it was allowed by the Church to deviate from the prescribed scheme. The assumption of a sacral place immediately adjacent to the prismatic tower cannot be confirmed or refuted.

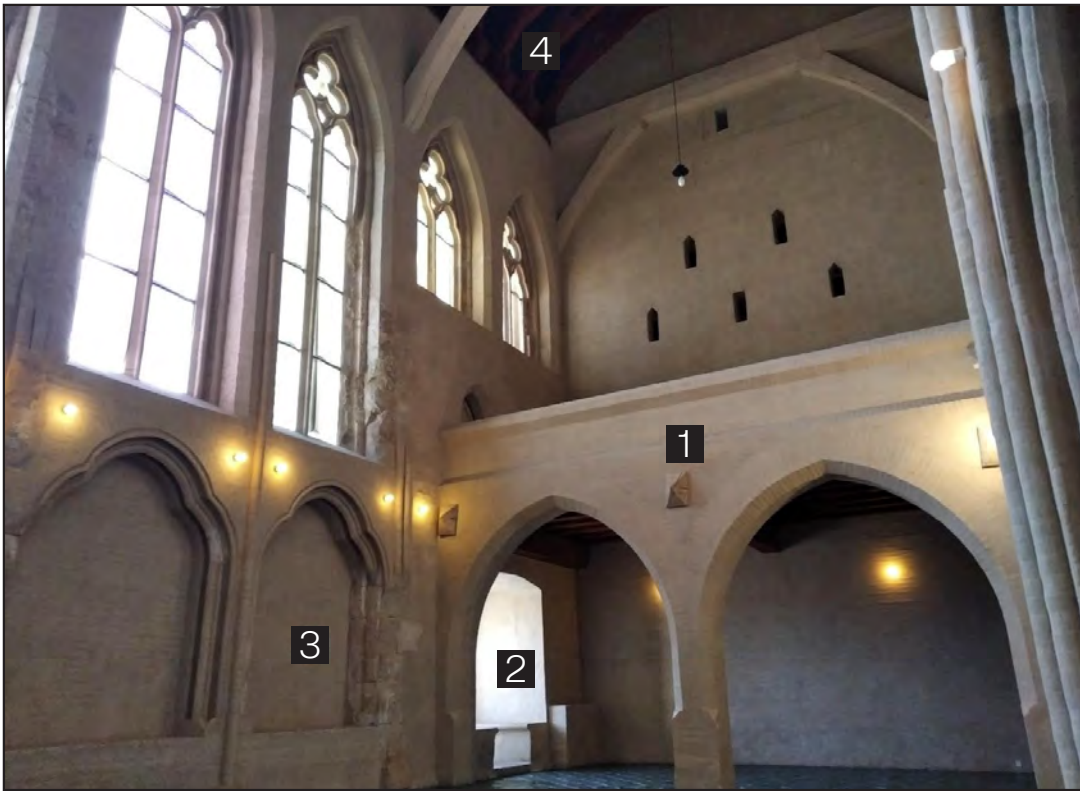
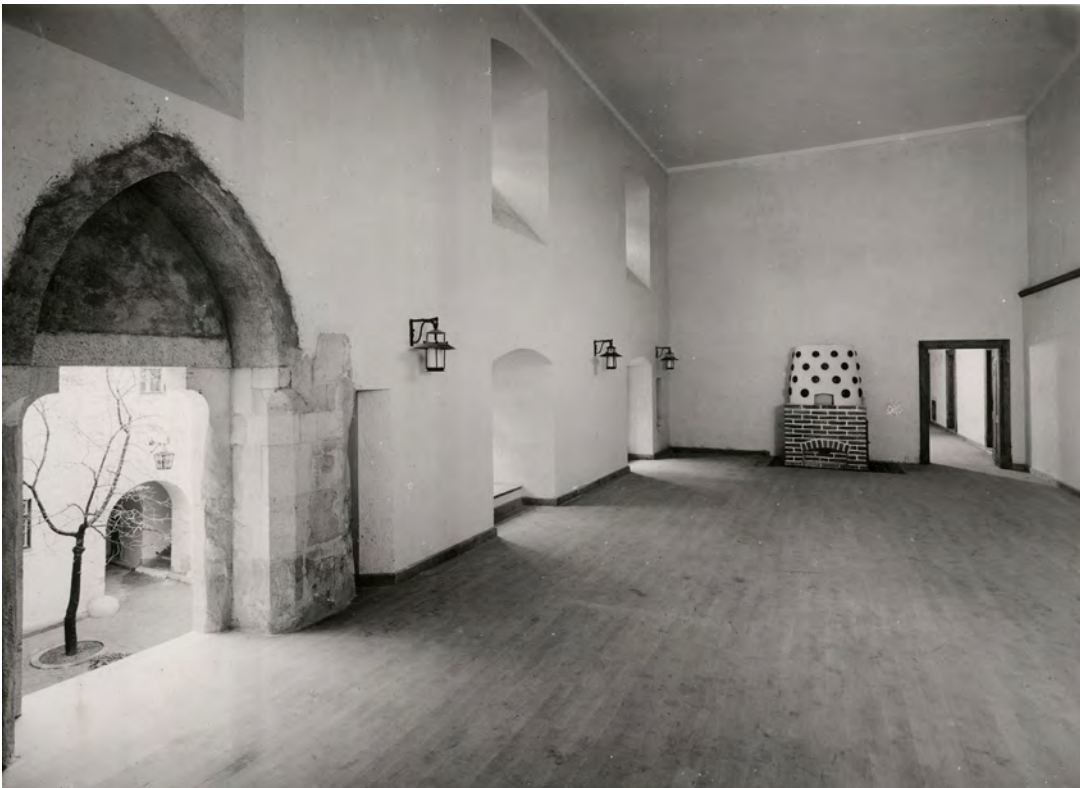
Royal Chapel

The royal chapel after the reconstruction for the purposes of the Wehrmacht between 1939 and 1941.

The so-called “royal chapel” is the key area of the eastern wing. It was originally vaulted with two diversely-sized bays of cross vaulting and lit by tall windows with a characteristic pointed arch. From the small courtyard it is possible to see the entrance portal to the room, decorated in an exceptionally elaborated manner, which was accessed from the courtyard by a wooden gallery indicated in the perimeter of the masonry. Nowadays the whole space has essentially two functional interpretations. Either it was the main meeting hall where the relevant monarch or his representative granted an audience, or it was actually the main chapel of the castle dedicated to St. John the Baptist.

During the reconstruction of the castle in 1997-2000, it was decided to uncover the preserved relics of the medieval masonry and to complete the missing structural elements into the form of the chapel mentioned above. A choir loft ❶ was built into the southern part of the room, covering an early Gothic window with seats in the thickness of the masonry ❷. The arcades with sedilia ❸ along the longer walls of the room were also reconstructed. The vault was not completed, so the room opens vertically into the roof trussing ❹ and enhances the impression of the most monumental room of Špilberk Castle.

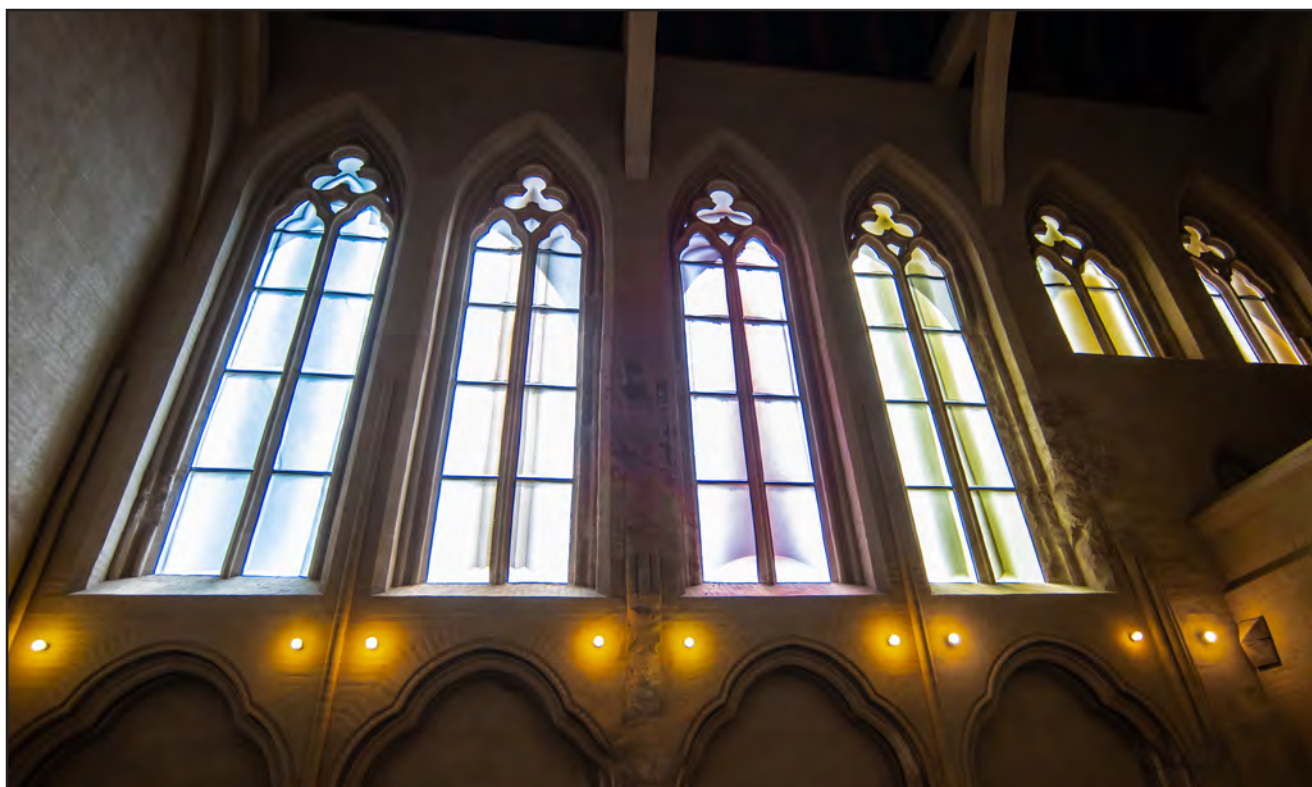
Stained glass in the east

The renovation of the oldest part of Špilberk Castle, the eastern wing, was completed in 2003 with the installation of new stained glass windows designed by *Stanislav Libenský* and *Jaroslava Brychtová*.

It was not a classical multicoloured stained glass, where individual panes are separated by metal, but each window is tinted in a shade of one colour. The leaded glass was coloured with unusual oxides of even golden tones to result in a shade corresponding to the importance of the historical site. The glass was then cut, polished and shaped to precise formats. The only similar works in our country is located in the St. Wenceslas
